**Flood Control Project Maintenance
Levee Inspections**

Maintenance Issue Types Only, Levee Inspection Report By Mile - Spring 2018

Reclamation District No. 0900 West Sacramento

Waterway	Bank	Unit Miles	Inspection Start/End	Inspector
Unit No. 01 Sacramento River	Right	7.70	03/13/2018 03/13/2018	Dave Torres

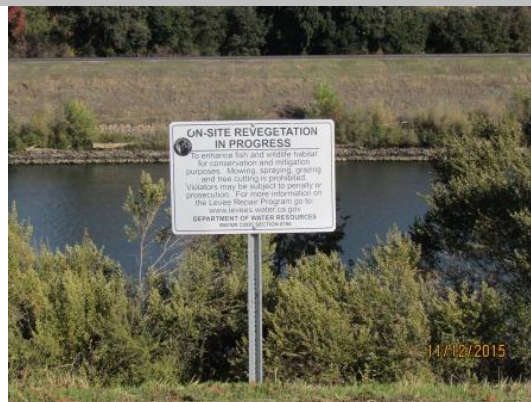
Photo 1 of 1 : SP_2018_RD0900_230_17_20180301_00009.jpg

LM Start	2.26	Rating **	A/W	Issue No.	17
LM End	3.72	Issue Type +	Ma	Location *	WS
Category	Earthen Levee			GPS Latitude/Longitude	
				Start	End
Item	Vegetation			38.555304 °	38.536946 °
				-121.516127 °	-121.519774 °
DWR ID	DWR_RD0900_01_s_2012_17				
Comment Code					
V8 : Environmental Requirements.					
Inspector Comment

View of the DWR environmental mitigation site.

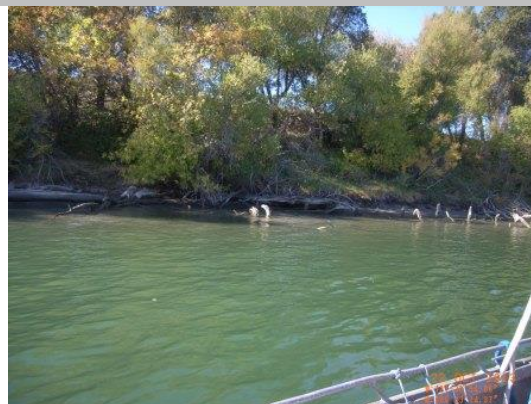
Photo 1 of 1 : SP_2018_RD0900_230_10_20180301_00006.jpg

LM Start	2.35	Rating **	M	Issue No.	10
LM End	2.47	Issue Type +	Ma	Location *	WS
Category	Supplemental			GPS Latitude/Longitude	
				Start	End
Item	2015 USACE Erosion Survey, DRAFT			38.554277 °	38.552504 °
				-121.515263 °	-121.514752 °
DWR ID	DWR_RD0900_01_s_2016_10				
Comment Code					
Inspector Comment					
2007 - Have good berm width with minor toe erosion. Close to the levee toe protection, but levee slope is steep. 2011 - New large erosion pocket. 2012 - Minor new erosion at the toe. 2015: No observed changes. [2015 Site ID: SAC_56-7_R]

USACE 2013 Photo #1

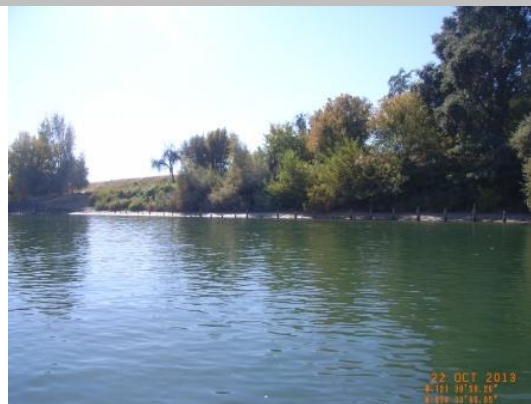
Photo 1 of 1 : SP_2018_RD0900_230_9_20180301_00005.jpg

LM Start	2.55	Rating **	M	Issue No.	9
LM End	2.64	Issue Type +	Ma	Location *	WS
Category	Supplemental			GPS Latitude/Longitude	
				Start	End
Item	2015 USACE Erosion Survey, DRAFT			38.551319 °	38.550090 °
				-121.514423 °	-121.513983 °
DWR ID	DWR_RD0900_01_s_2016_9				
Comment Code					
Inspector Comment					
1997 - Low berm is contributing to erosion. Old timber pile dikes above water parallel to bank. The upstream mitigation low berm causes a flow separation at the site. 1999 - Some new localized erosion with less than one foot of bank retreat. 2000 - Some new erosion at the upstream end. Fat toe deposits at toe. 2003 - Some new erosion upstream, but have a wide berm. 2011 - Minor new erosion at toe. 2015: No observed changes. [2015 Site ID: SAC_56-5_R]

USACE 2013 Photo #1

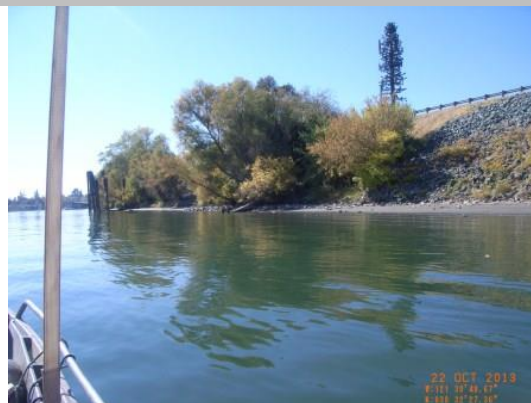
Photo 1 of 1 : SP_2018_RD0900_230_2_20180301_00002.jpg

LM Start	3.27	Rating **	M	Issue No.	2
LM End	3.48	Issue Type +	Ma	Location *	WS
Category	Supplemental			GPS Latitude/Longitude	
				Start	End
Item	2015 USACE Erosion Survey, DRAFT			38.541246 °	38.538689 °
				-121.513561 °	-121.515916 °
DWR ID	DWR_RD0900_01_s_2016_2				
Comment Code					
Inspector Comment					
2008 - Erosion into levee toe. Over steepened levee slope, worst at the upstream end. 2009 - Near vertical banks from rotational slumping, hidden by vegetation. 2010 - Boat sinking more, may be causing eddy scour around it. Difficult to see the vertical slumps due to dense vegetation. 2011 - Minor new erosion at the toe. The paddleboat that was sitting at this site for years has been removed. 2012 - Site extended upstream due to additional erosion. 2015: No observed changes. [2015 Site ID: SAC 55-7 R]

USACE 2013 Photo #1

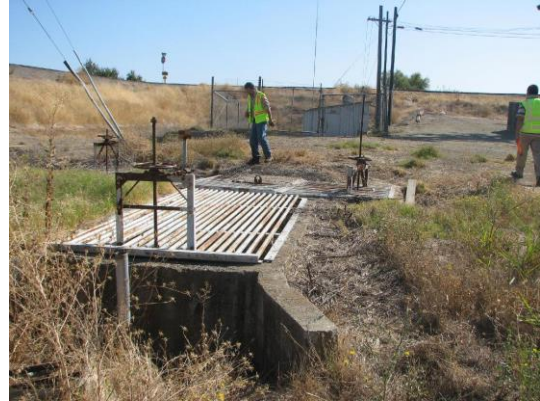
Photo 1 of 3 : UCIP_SP_2018_37668_68391.jpg

FS_ID:37668
DS_ID:17769
EP_NO: N/A
Repair Type: Non-Urgent
Crossing Status: Found
UCIP Comments: 02/26/2018 Pipe is located within the construction limits of the Levee Improvement Project for RD0900, As-builts PENDING Project Completion. -- UNDER CONSTRUCTION Levee Improvement Project, construction schedule Summer 2016 to November 2018. Levee improvements address through seepage, underseepage and slope stability and include strengthen-in-place improvements and construction of a setback levee. Reference: [Issued FOR CONSTRUCTION] West Sacramento Area Flood Control Agency Southport Levee Improvement Project Early Implementation Program. Southport Sacramento River Levee: (Stat 3+90 to Station 287+57). Volume 3 (W.O. # 41164) December 2016 Conformed Submittal. HDR Engineering Inc. Folsom, CA – (DWR UCIP – O. Magana)
10/06/2009 Dense vegetation limits the inspector's visibility to identify signs of pipe failure (leaks) along the slope. Recommend removing vegetation along pipe alignment to conduct proper inspection of structure and appurtenances. (DWR UCIP - O. Magana)

FIELD_STRUCT_DESC: 24-inch pipe through the levee, 22.0 feet below the crown. Pump house at the landside (LS) toe. Screw gate in LS of the levee.
Additional Reference(s): USACE Sacramento O&M Manual Unit No. 116, August 1955, revised 2011, (USGS River Mile [RM] 55.65), As-built drawing# 6-13-1100 page 3, January 1933]
FS Date: 10/6/2009

View of concrete structure located on landward side.

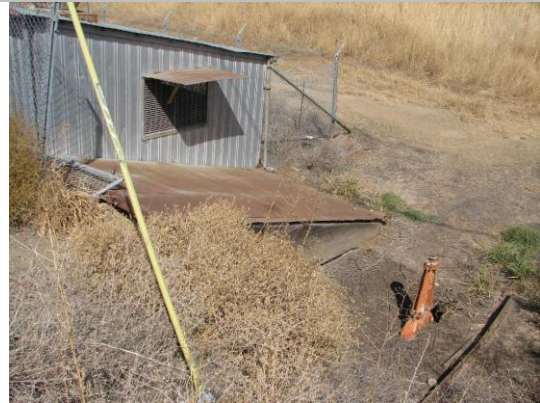
Photo 2 of 3 : UCIP_SP_2018_37668_68390.jpg

Pump house located on landward side.

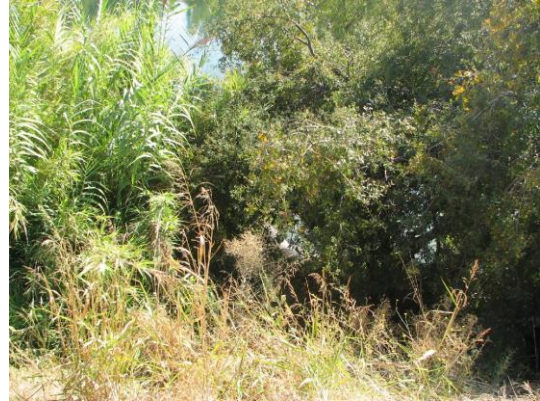
Photo 3 of 3 : UCIP_SP_2018_37668_68389.jpg

Pipe visible on waterward side visible through dense vegetation.

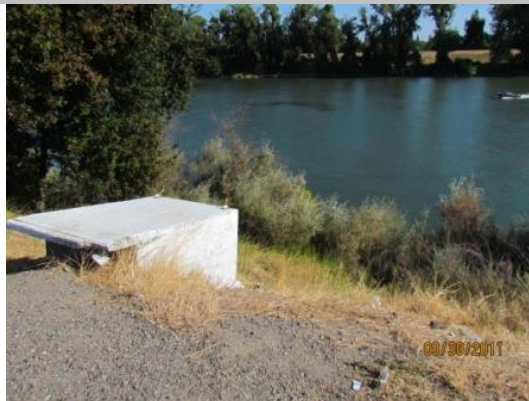
Photo 1 of 1 : SP_2018_RD0900_230_330_20180301_00016.jpg

LM Start	4.95	Rating **	M	Issue No.	330
LM End	4.95	Issue Type +	Ma	Location *	WS
Category	Earthen Levee			GPS Latitude/Longitude	
				Start	End
Item	Encroachments			38.524898 °	38.524898 °
				-121.529674 °	-121.529674 °
DWR ID	DWR_RD0900_01_s_2012_330				
Comment Code					
DE : Debris					
Inspector Comment

Concrete anchor was found on the waterside slope of the levee looking upstream.

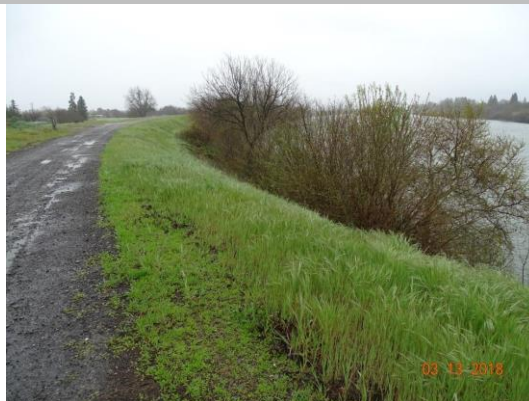
Photo 1 of 1 : SP_2018_RD0900_230_24_20180314_00024.jpg

LM Start	7.00	Rating **	M	Issue No.	24
LM End	7.03	Issue Type +	Ma	Location *	WS
Category	Earthen Levee			GPS Latitude/Longitude	
				Start	End
Item	Vegetation			38.513834 °	38.513556 °
				-121.554017 °	-121.554283 °
DWR ID	DWR_RD0900_01_s_2018_24				
Comment Code					
V2 : Remove the wild growth other than native grasses from the levee slopes.					
Inspector Comment

Vegetation waterside looking north.

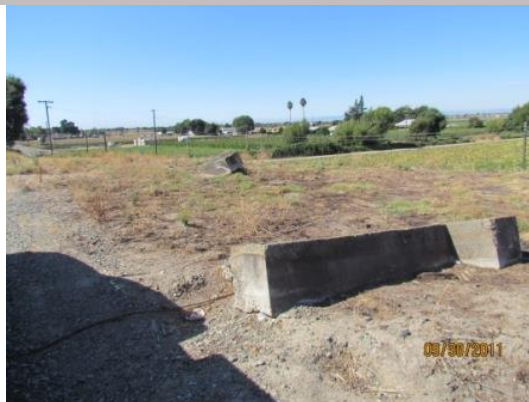
Photo 1 of 1 : SP_2018_RD0900_230_343_20180301_00017.jpg

LM Start	7.10	Rating **	M	Issue No.	343
LM End	7.10	Issue Type +	Ma	Location *	LS
Category	Earthen Levee			GPS Latitude/Longitude	
				Start	End
Item	Encroachments			38.512642 °	38.512642 °
				-121.554881 °	-121.554881 °
DWR ID	DWR_RD0900_01_s_2012_343				
Comment Code					
DE : Debris					
Inspector Comment					
Concrete debris from old railroad track.

Concrete debris from old rail road track was found on the landside of the levee looking upstream.

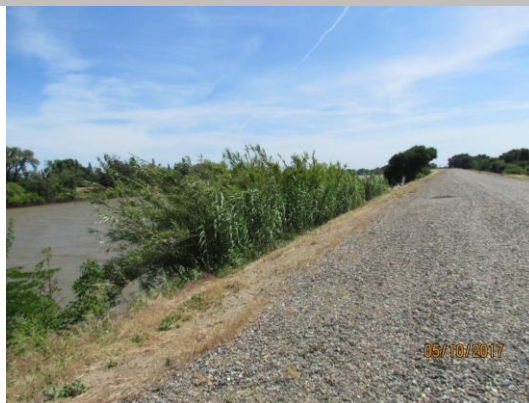
Photo 1 of 1 : SP_2018_RD0900_230_59_20180301_00014.jpg

LM Start	7.47	Rating **	M	Issue No.	59
LM End	7.47	Issue Type +	Ma	Location *	WS
Category	Earthen Levee			GPS Latitude/Longitude	
				Start	End
Item	Vegetation			38.507648 °	38.507648 °
				-121.557571 °	-121.557571 °
DWR ID	DWR_RD0900_01_f_2012_59				
Comment Code					
V2 : Remove the wild growth other than native grasses from the levee slopes.					
Inspector Comment					
Arrundo growth on the waterside slope of the levee.

View of the arundo on the waterside of the levee during spring 2017 inspection.

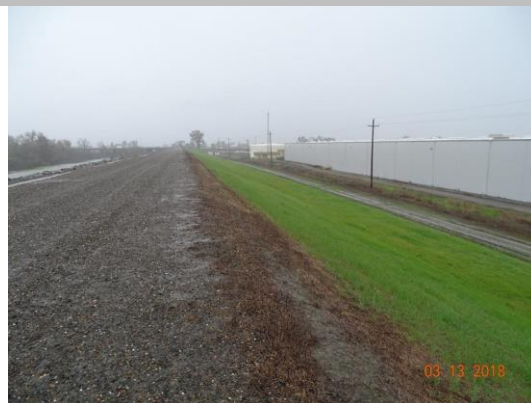
Photo 1 of 1 : SP_2018_RD0900_231_17_20180314_00050.jpg

LM Start	1.30	Rating **	A	Issue No.	17	
LM End	1.30	Issue Type +	Ma	Location *	LS	
Category	Earthen Levee			GPS Latitude/Longitude		
				Start		End
Item	Vegetation			38.569404 °		38.569404 °
				-121.582193 °		-121.582193 °
DWR ID	DWR_RD0900_02_s_2018_17					
Comment Code						
V1 : Control annual grass and weeds on the levee slopes and easements.						
Inspector Comment						
LMA is doing a good job with vegetation control.

Good vegetation control landside looking north.

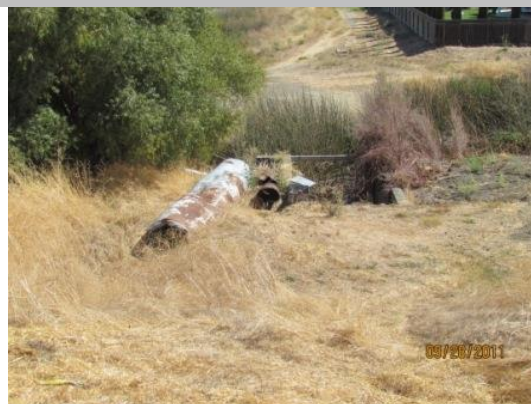
Photo 1 of 1 : SP_2018_RD0900_231_15_20180301_00002.jpg

LM Start	3.26	Rating **	M	Issue No.	15
LM End	3.26	Issue Type +	Ma	Location *	LS
Category	Earthen Levee			GPS Latitude/Longitude	
				Start	End
Item	Encroachments			38.540943 °	38.540943 °
				-121.582280 °	-121.582280 °
DWR ID	DWR_RD0900_02_s_2012_15				
Comment Code					
PI : Pipe					
Inspector Comment					
Recently removed waterward pump. Some pipe remains.

Abandon pipes and debris was found on the landside of the levee looking upstream.

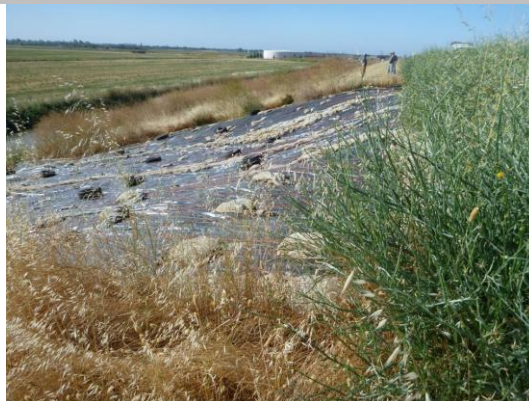
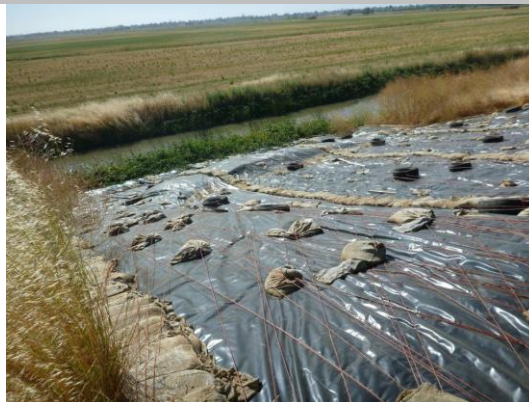
Notes: LS, thorny vegetation is present at levee toe/canal. Light grass present along LS slope. Primary use of canal is for drainage, ranges in width 15-25; on average 20ft. RD rep. mentioned permitting has begun to replace drainage canal with 32in pipe for storm drainage to community. 8,600 LF of the LS levee has sloughing of the LS toe access road into drainage canal. There is no imminent threat of losing levee in next storm event. DWR inspector: LMA repaired two landslide erosion sites (levee mile 5.26 and 4.63) during fall 2017 inspection.

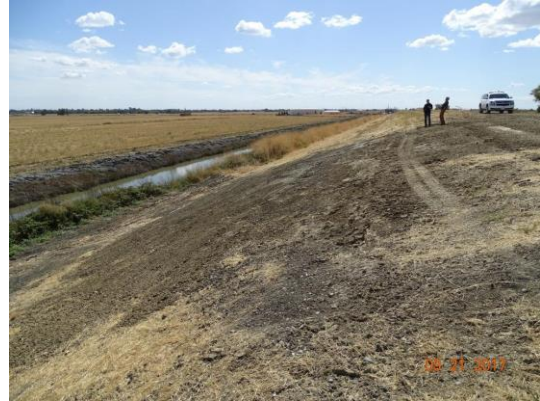
Photo 7 of 7 : SP_2018_RD0900_231_40_20180301_00009.jpg

View of a repaired slope instability site on the landside of the levee looking downstream on levee mile 4.63 (38.52111, -121.582148). Fall 2017

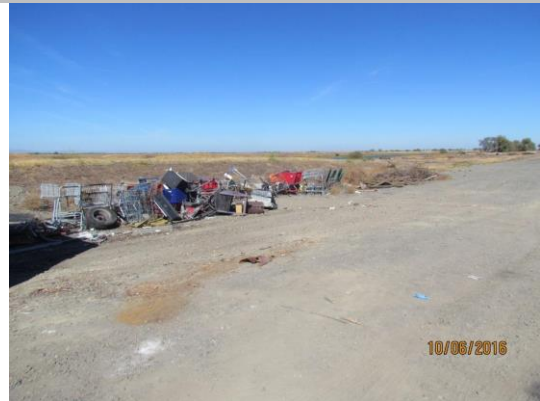
Photo 1 of 1 : SP_2018_RD0900_231_45_20180301_00010.jpg

LM Start	5.04	Rating **	M	Issue No.	45
LM End	5.04	Issue Type +	Ma	Location *	LS
Category	Earthen Levee			GPS Latitude/Longitude	
				Start	End
Item	Encroachments			38.515091 °	38.515091 °
				-121.582178 °	-121.582178 °
DWR ID	DWR_RD0900_02_f_2016_45				
Comment Code					
DE : Debris					
Inspector Comment

View of debris on the landside shoulder of the levee looking upstream.
